Manhole Inspection Summary

Manhole # S25C__030MH

Insp Date: **8/6/07 7:10 AM**

Location Address: **1024 FRANKLIN ST**

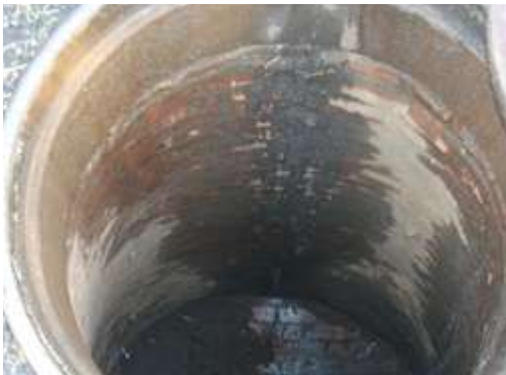
Defect 3

Steps Count: **0** Missing: **5** ☐ Corroded

ALL STEPS MISSING

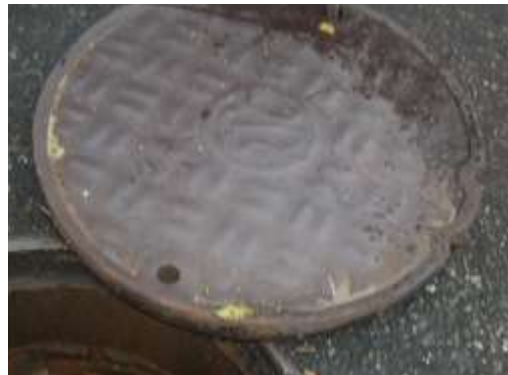
Defect 2

Type: **Sanitary** Condition: **Worn** Cover Material: **Cast Iron**

WORN COVER

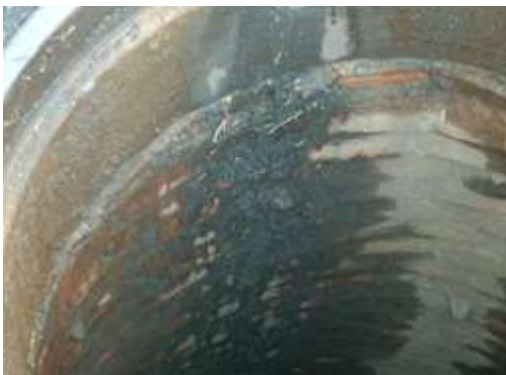
Defect 1

Infiltration: ☐ None ☐ Joint ☐ Cracks ☐ Mortar ☐ Roots ☒ **Wall**

INFILTRATION OF CHIMNEY

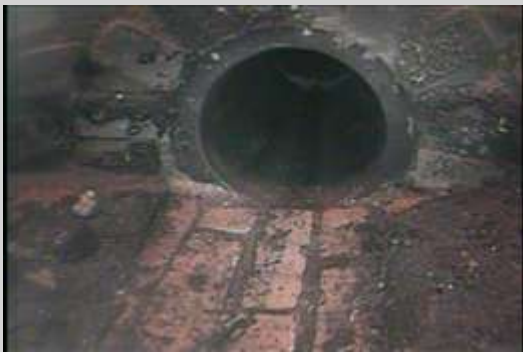
12 O'Clock Outflow

8 in. Circular Gravity Sewer
Pipe Out @ 12 O'Clock

Pipe Height: **8.4** (in.) Rod and Bar (Angled)
Pipe Material: **Clay** ☐ Pipe Lined
Invert Depth: **9.36** (ft.) Flow Characteristics: **None**
Deposits: ☒ None ☐ Mud ☐ Sludge ☐ Debris ☐ Grease
Silt Depth: (in.) Deposits Extent:
Infiltration: **None** Pipe Seal Cond: **Sound**

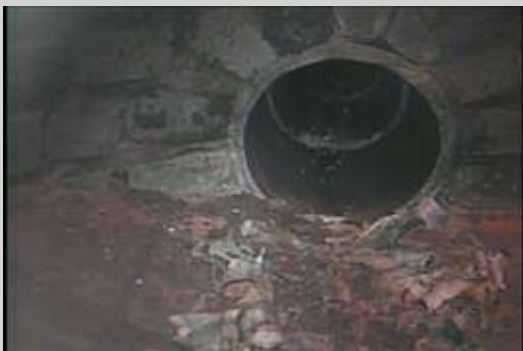
6 O'Clock Inflow

8 in. Circular Gravity Sewer
Pipe Out @ 6 O'Clock

Pipe Height: **8.4** (in.) Rod and Bar (Angled)
Pipe Material: **Clay** ☐ Pipe Lined
Invert Depth: **9.24** (ft.) Flow Characteristics: **None**
Deposits: ☒ None ☐ Mud ☐ Sludge ☐ Debris ☐ Grease
Silt Depth: (in.) Deposits Extent:
Infiltration: **None** Pipe Seal Cond: **Sound**
